# QMM – High level incident summary report

Mine process water overflow into adjacent wetland incident  
17 February 2022

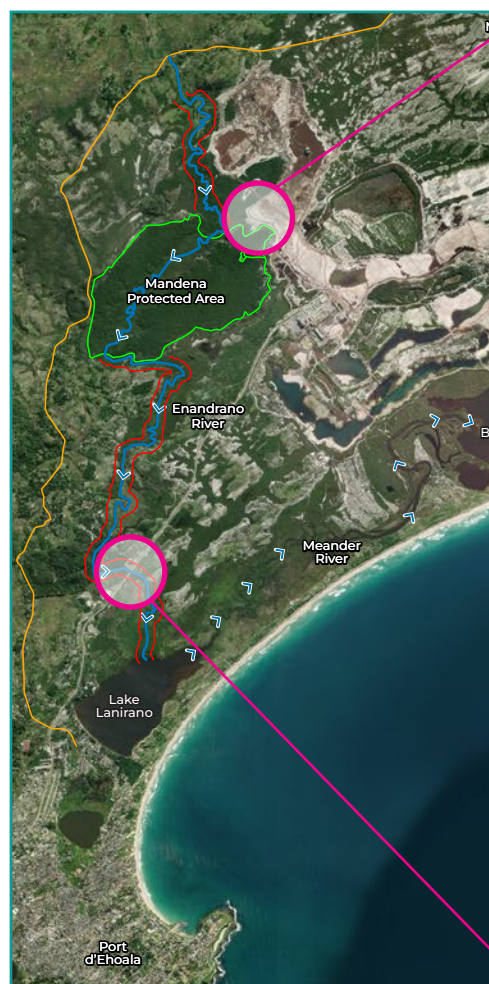
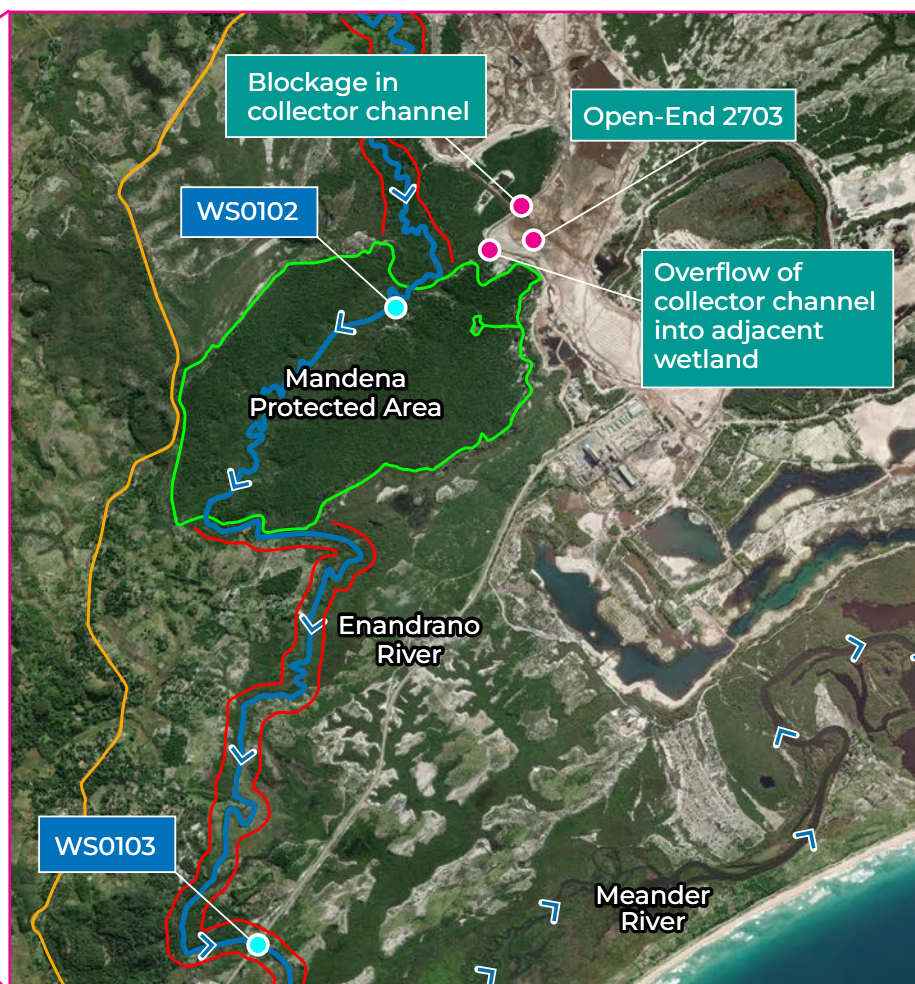
On 17 February, a water flow incident occurred from a mine canal, called collector channel, into the wetland adjacent to the mine leading to the Enandrano river. Investigations established that a slurry from a pipe outlet at the back of the mining pond (Open End 2703) accumulated in the collector channel until it was completely obstructed. The blockage raised the water level of the collector channel causing an overflow of an estimated 7650m<sup>3</sup> lasting less than six hours. As soon as detected, the overflow was immediately rectified by the QMM team.

Inspection of open end was not frequent enough to alert QMM that slurry was being discharged to the collector channel and not into the mining pond.

Health Safety & Environment risk analysis for the change in infrastructure configuration was not undertaken.

The inspection procedure of the Open-End discharge/channel area to be reviewed with respect to frequency, accessibility for inspection purposes and reporting of non-conformances.

The preliminary design and risk assessment for any new infrastructure is to identify environmentally sensitive areas and detail potential mitigation in the event of any future overflow incidents.

Standard work procedure for inspection of Open End discharge has been updated for this activity.

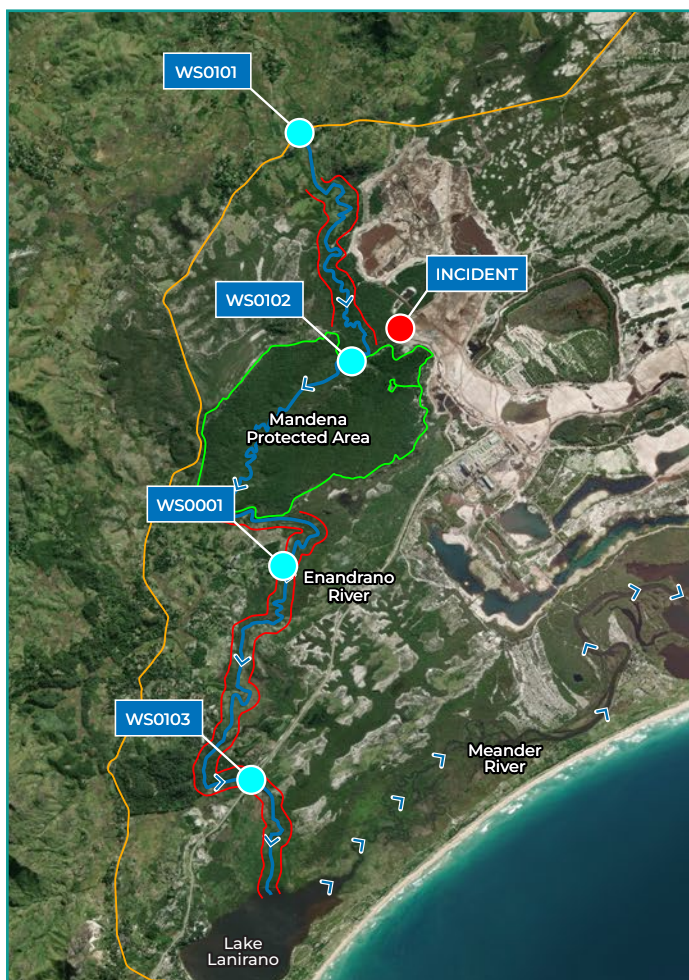
- Water monitoring results confirmed there were no measurable and observable environmental impacts as a result of the overflow event.
- No significant impact on pH from upstream to downstream.
- The river color was becoming clearer from upstream to downstream.
- There was a temporary increase in aluminum levels from upstream to downstream in the 17 February samples, potentially due to water coming back from flooded area caused by cyclone activity. However, the measured aluminium content on the drinking water was less than 0.9mg per litre, which is below the WHO guideline.

Water quality monitoring was undertaken at several sampling points:

- WS0101: Upstream sampling point, reference station not impacted by QMM operation
- WS0102: Incident sampling point (Enandrano river vs wetland)
- WS0001: Community bridge
- WS0103: Downstream sampling point
