QMM's encroachment onto the lake bed - comparing satellite images: 2009 and 2016

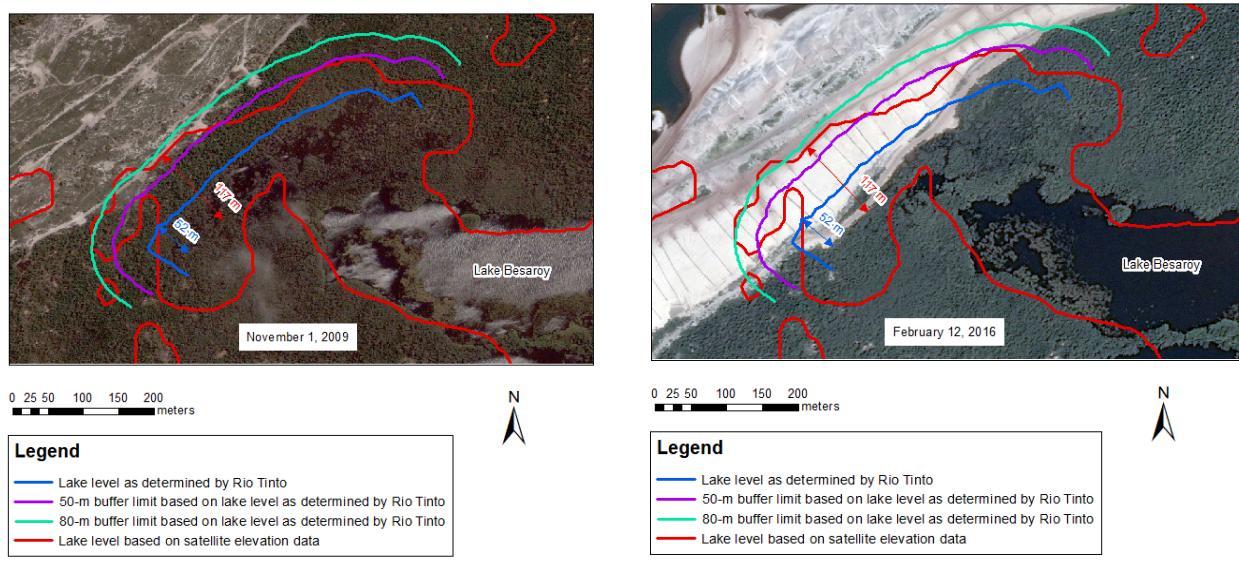
Figure 1a Buffer zone area in question in 2009

Figure 1b Buffer zone area in question in 2016

The satellite images were obtained from Google Earth and are dated 1st November 2009 and February 12, 2016.

Using an Ordinary High Water Level (OHWL) provided by Rio Tinto (0.6 masl), defined by the **blue line** in both images, the Ozius study measures that mine encroachment has proceeded 52 metres onto the lake bed (**see blue arrow**).

Emerman, using a more accurate OHWL (4.6 masl) defined by the **red outline**, demonstrates QMM's encroachment of 117metres onto the bed of Lake Besaroy (**red arrow**).

When the 50metre buffer, represented by the **purple line** using an OHWL of 0.6 masl is used (Ozius), the total violation of the buffer is 52 + 50 = 102metres.

Using 4.6 masl as the OHWL, the buffer must be set back from edge of the lake (**red line**) by 50metres, so that total violation equates to 117 + 50 = 167metres (Emerman, 2018). These violations are clear when comparing the two images across the different time periods.

Dr. Emerman has studied the Lidar mapping data used by Ozius and provided an addendum to his report to address the discrepancies in the respective calculations (Emerman 2018). These are due to Ozius accepting Rio Tinto's assumption of a 0.6-masl OHWL – which is incorrect by RT's own admission; and using different data (Lidar vs. NASA satellite elevation data). The Lidar data (collected in 2012), according to Dr. Emerman, does not measure the water level of the lake or much of the buffer area in question. It is of poor quality, lacking methodological explanation.
